DTC	B1217 / 17	Rear left door ECU communication stop
------------	-------------------	--

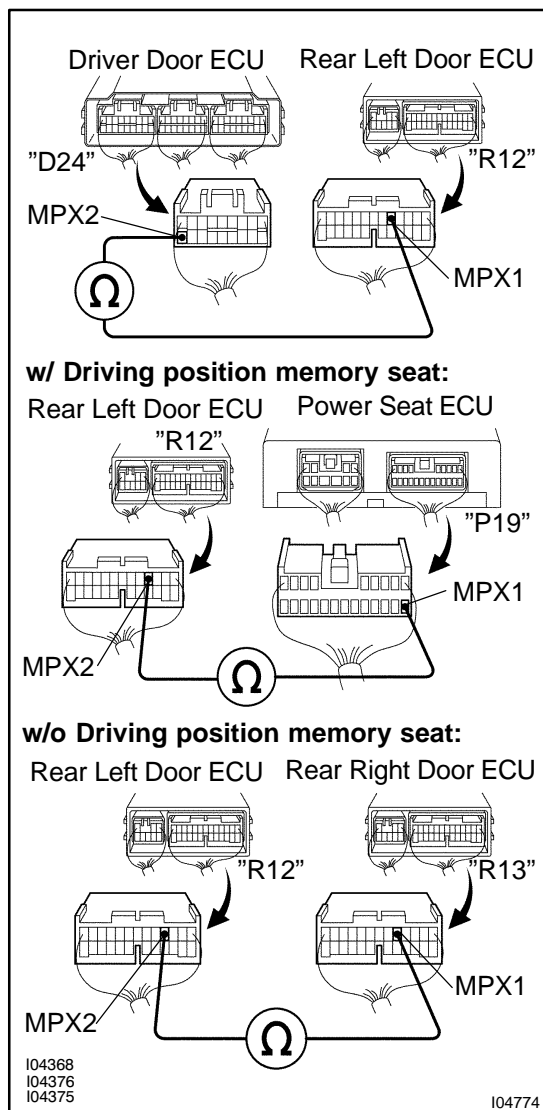
Disconnect connector "D24" of driver door ECU, "R12" of rear left door ECU and "P19" of power seat ECU (or "R13" of rear right door ECU).

- (a) Check continuity between terminals MPX2 of driver door ECU and MPX1 of rear left door ECU.
- (b) w/ Driving position memory seat:
Check continuity between terminals MPX2 of rear left door ECU and MPX1 of power seat ECU.
- (c) w/o Driving position memory seat:
Check continuity between terminals MPX2 of rear left door ECU and MPX1 of rear right door ECU.

There is a continuity in wireharness of both (a) and (b) or (a) and (c), (a) or either (b) or (c).

If there is OPEN in wireharness of either (a), (b) or (c), please repair it.

Repair or replace wireharness.

Replace the rear left door ECU.
