DTC	B1218 / 18	Body ECU No. 2 communication stop
------------	-------------------	--

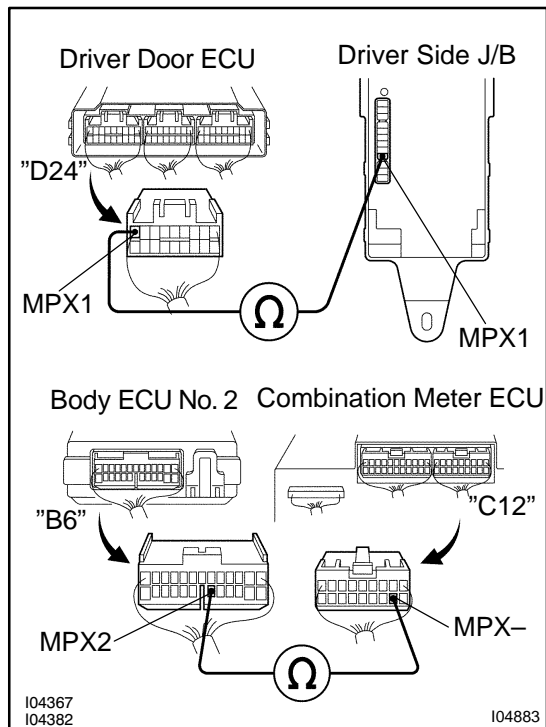
Check wireharness

- Check continuity between terminals MPX1 of Body ECU No. 2 and MPX1 of Driver door ECU.
- Check continuity between terminals MPX2 of Body ECU No. 2 and MPX- of Combination meter ECU.

There is a continuity in wireharness of both (a) and (b), or either (a) or (b).

If there is OPEN in wireharness of either (a) or (b), please repair it.

NG**Repair or replace wireharness.****OK****Replace the Body ECU No. 2.**
