DTC	B1273 / 73	Sliding roof ECU communication stop (w/ Sliding roof vehicle only)
------------	-------------------	---

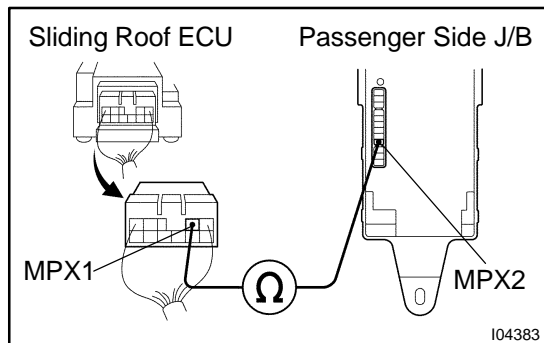
2**Check wireharness**

Check continuity between terminals MPX2 of Body ECU No. 1 and MPX1 of sliding roof ECU.

There is a continuity in wireharness.

NG**Repair or replace wireharness.****OK****Replace the sliding roof ECU.**
