FRONT LOWER BALL JOINT ON-VEHICLE INSPECTION

SAORP-01

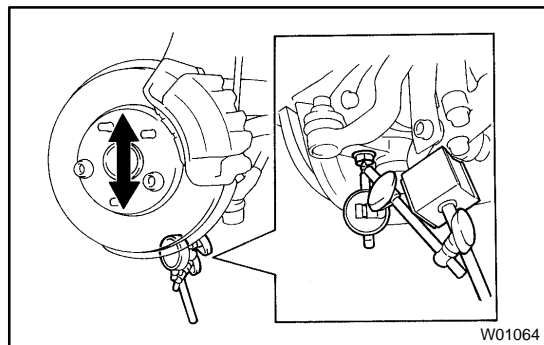
INSPECT LOWER BALL JOINT EXCESSIVE PLAY ON-VEHICLE

- (a) Remove the tire and install the hub nuts to the disc.
- (b) Using a dial indicator, check the lower ball joint for excessive play when you push the hub nuts up and down with a force of 294 N (30 kgf, 66 lbf).

Maximum: 0.9 mm (0.035 in.)

If it is not within the specification, replace the lower ball joint.
