## REPLACEMENT OF REPAIR WIRE FOR FRONT AIRBAG SENSOR

## REPLACEMENT OF AIRBAG REPAIR WIRE

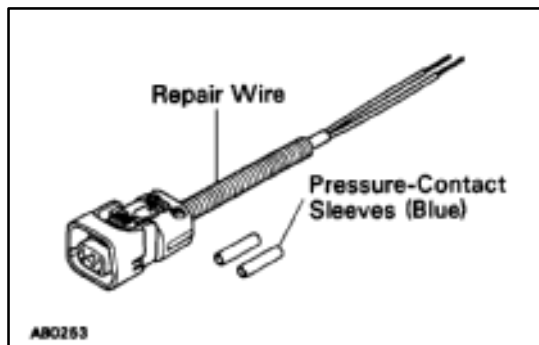
Repair wire with two pressure-contact sleeves (Part No. 82988-50010) has been prepared for exclusive use in repairing connector damage etc. caused by frontal collision of the vehicle. When repairing the front airbag sensor connector on the wire harness side, always use the special repair wire.

**NOTICE:** Do not replace the connector housing or terminal only.

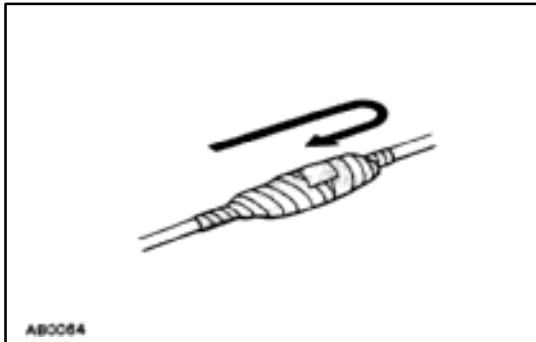
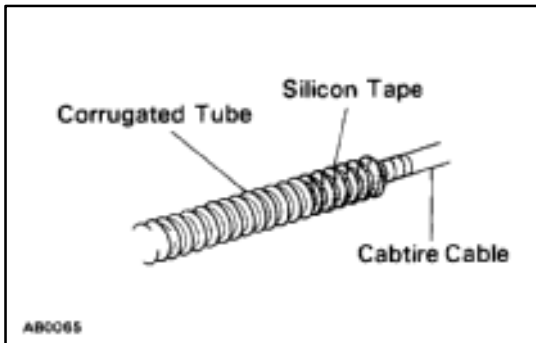
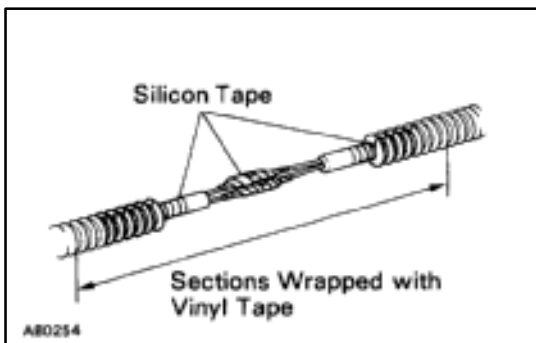
### 3. PROTECT JOINED SECTION

Wrap silicon tape around the joins to protect them from water.

- Do not let oil and dust, etc. get on the tape surface.
- (a) Ready about 100 mm (3.94 in.) of silicon tape (Part No. 08231-00045) and peel off the film.

- (b) Stretch the silicon tape until its width is reduced by half.
  - (c) About 10 mm (0.39 in.) from the end of the pressure-contact sleeve, wrap the silicon tape around the sleeve three or more times while stretching the tape.

- (d) Wrap the remaining part of sleeve with half of the tape overlapping at each turn.
  - (e) Firmly wrap the tape two times or more about 10 mm (0.39 in.) from the other end of the pressure-contact sleeve, then wrap the tape back towards the start again and firmly finish winding the tape around the center of the sleeve.

- (f) Fix the corrugated tube to the cabtire cable using silicon tape.
  - (g) After applying the silicon tape, apply vinyl tape on the corrugated tube of repair wire side over to the corrugated tube of vehicle wire harness side.
