INSPECTION

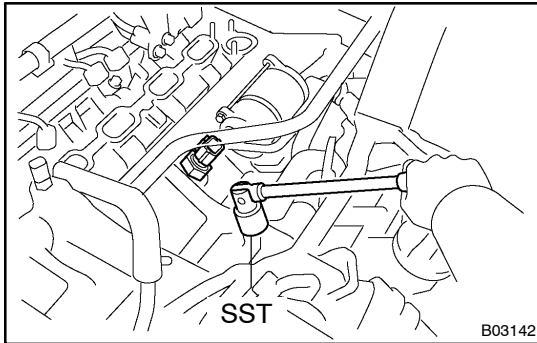
5. REMOVE KNOCK SENSOR
 - (a) Disconnect the knock sensor connectors.
 - (b) Using SST, remove the 2 knock sensors.
SST 09816-30010

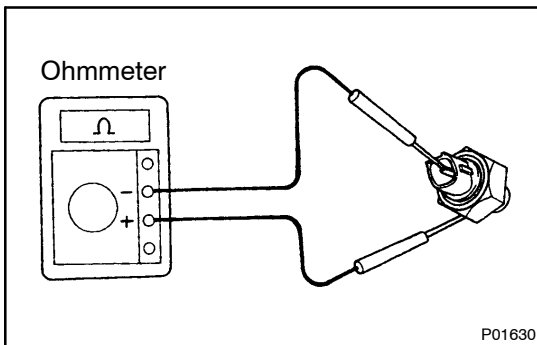
6. INSPECT KNOCK SENSOR
Using an ohmmeter, check that there is no continuity between the terminal and body.
If there is continuity, replace the sensor.

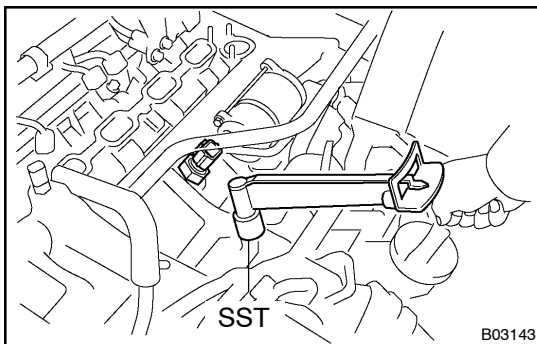
7. REINSTALL KNOCK SENSOR
 - (a) Using SST, install the 2 knock sensors.
SST 09816-30010
Torque: 44 N·m (450 kgf·cm, 33 ft·lbf)
 - (b) Connect the knock sensor connectors.
8. REINSTALL INTAKE MANIFOLD ASSEMBLY
(See page EM-54)
9. RECONNECT THROTTLE BODY
(See page SF-61)
10. CHECK FOR FUEL LEAKS
(See page SF-1)
11. REINSTALL INTAKE AIR CONNECTOR
12. REINSTALL V-BANK COVER
