## INSPECTION

### 1. INSPECT TIMING BELT

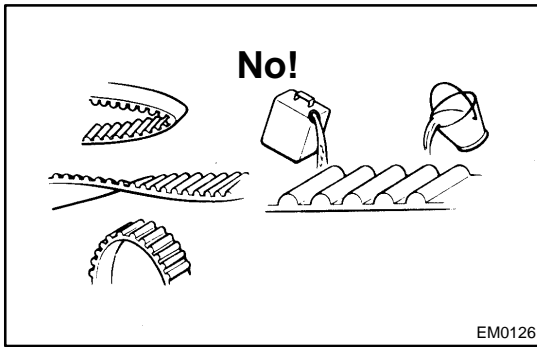
If there are any defects, as shown in the illustrations, check the following points.

- Premature parting
  - Check for proper installation.
  - Check the timing cover gasket for damage and proper installation.
- If the belt teeth are cracked or damaged, check to see if either camshaft is locked.
- If there is noticeable wear or cracks on the belt face, check to see if there are nicks on the side of the idler pulley lock.
- If there is wear or damage on only one side of the belt, check the belt guide and the alignment of each pulley.
- If there is noticeable wear on the belt teeth, check timing cover for damage and check gasket has been installed correctly and for foreign material on the pulley teeth.

If necessary, replace the timing belt.

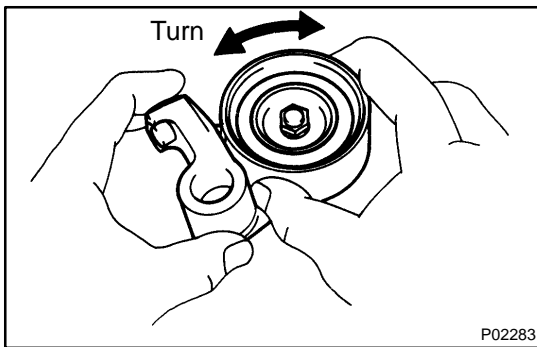
### 2. INSPECT IDLER PULLEY

- Visually check the seal portion of the idler pulley for oil leakage.

If leakage is found, replace the idler pulley.

- Check the turning smoothness of the idler pulley.

If necessary, replace the idler pulley.

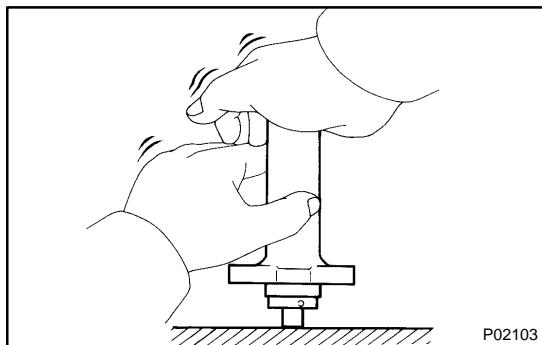
### 4. INSPECT TIMING BELT TENSIONER

- Visually check tensioner for oil leakage.

If there is only the faintest trace of oil on the seal on the push rod side, the tensioner is all right.

If leakage is found, replace tensioner.

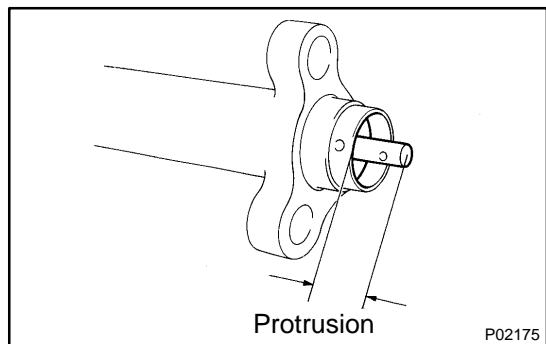
- (b) Hold the tensioner with both hands and push the push rod strongly against the floor or wall to check that it doesn't move.

If the push rod moves, replace the tensioner.
