INSPECTION

5. INSPECT KNOCK SENSOR 1, 2

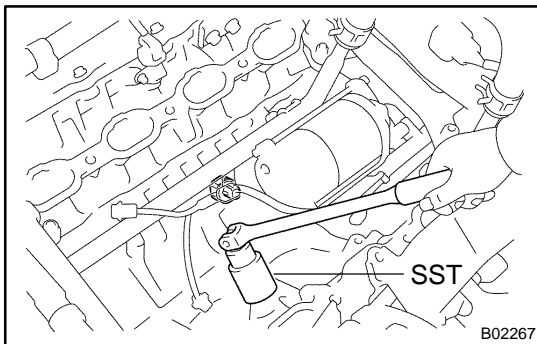
- (a) Disconnect the knock sensor connectors.
- (b) Using an ohmmeter, check that there is no continuity between the terminal and body.

If there is continuity, replace the sensor with SST.

SST 09816-30010

Torque: 45 N·m (450 kgf·cm, 33 ft·lbf)
