Horn circuit

CIRCUIT DESCRIPTION

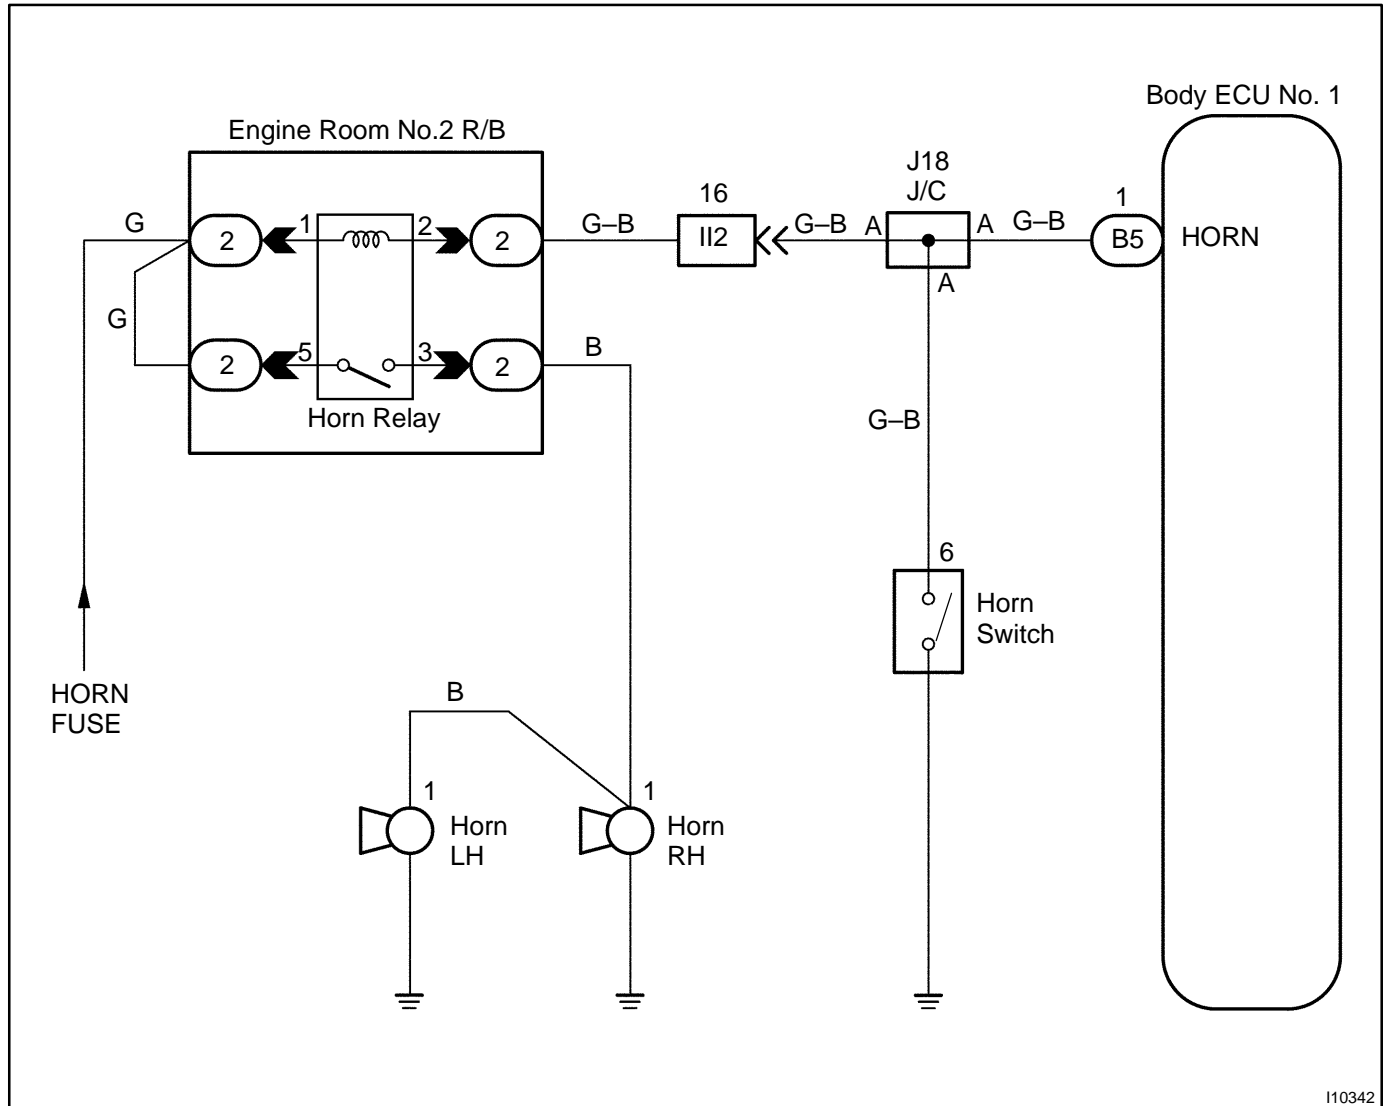
I10342

The horn is connected to the Body ECU No. 1 and activated by the Body ECU No. 1 during warning of the theft deterrent system.

WIRING DIAGRAM

2	Check wireharness and connector between horn relay and body ECU No. 1, battery and horn relay.
----------	---
