Theft deterrent horn circuit

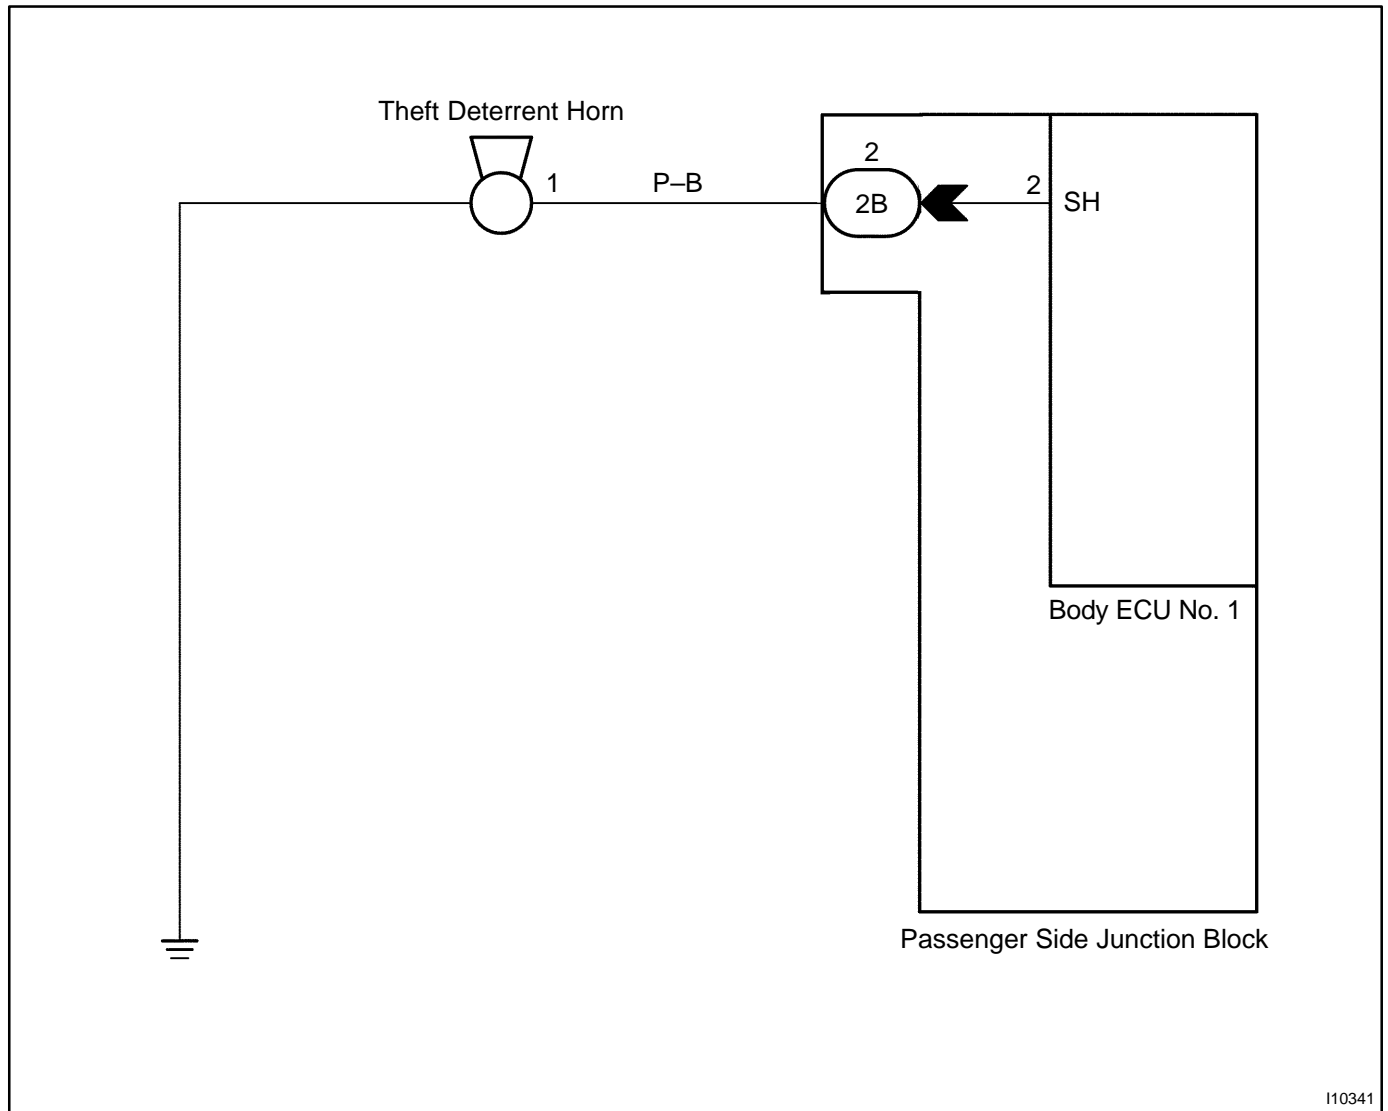
I10341

During warning of the theft deterrent system, the Body ECU No. 1 activates the theft deterrent horn.

WIRING DIAGRAM

3	Check wireharness and connector between theft deterrent horn and Body ECU No. 1.
---	--
