DTC	B0135/73	Short in P/T Squib (LH) Circuit
------------	-----------------	--

CIRCUIT DESCRIPTION

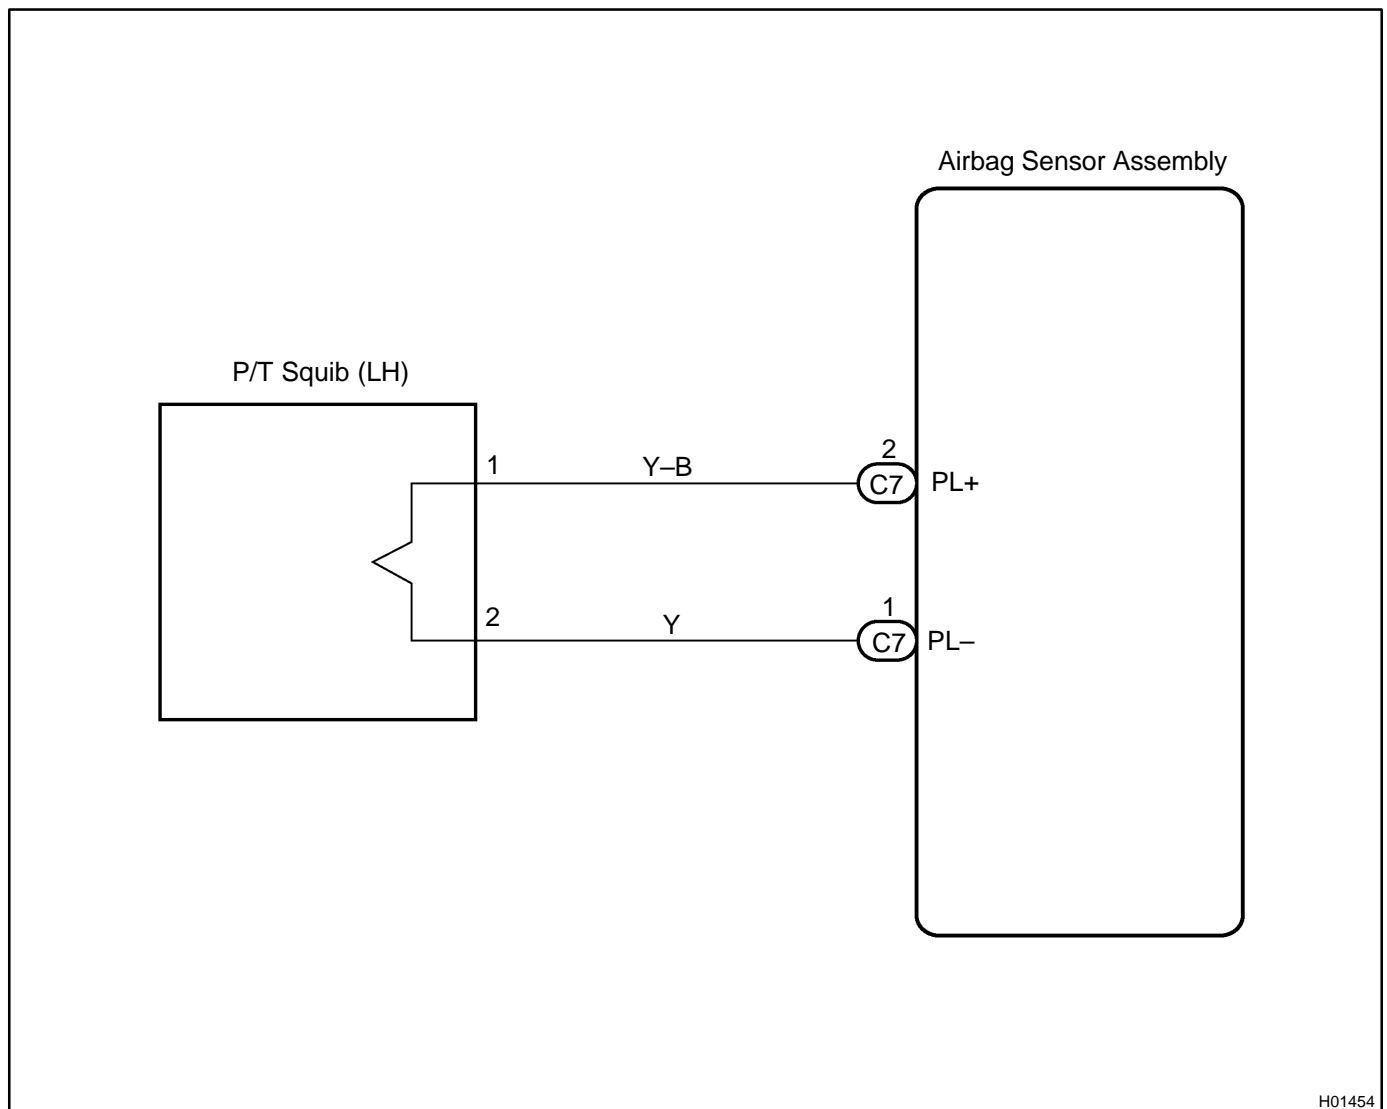
H01454

The P/T squib (LH) circuit consists of the airbag sensor assembly and seat belt pretensioner (LH). It causes the SRS to deploy when the SRS deployment conditions are satisfied. For details of the function of each component, see OPERATION on page [RS-2](#). DTC B0135/73 is recorded when a short is detected in the P/T squib (LH) circuit.

WIRING DIAGRAM

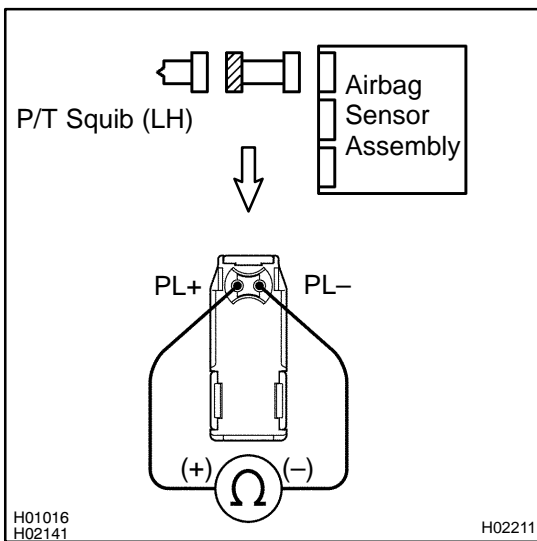
- 2 Check P/T squib (LH) circuit.

Release the airbag activation prevention mechanism of the connector (on the airbag sensor assembly side) between the airbag sensor assembly and the seat belt pretensioner (LH) (See page [DI-650](#)).

For the connector (on the seat belt pretensioner side) between the seat belt pretensioner (LH) and the airbag sensor assembly, measure the resistance between PL+ and PL-.

Resistance: 1 MΩ or Higher

Repair or replace harness or connector between seat belt pretensioner (LH) and airbag sensor assembly.

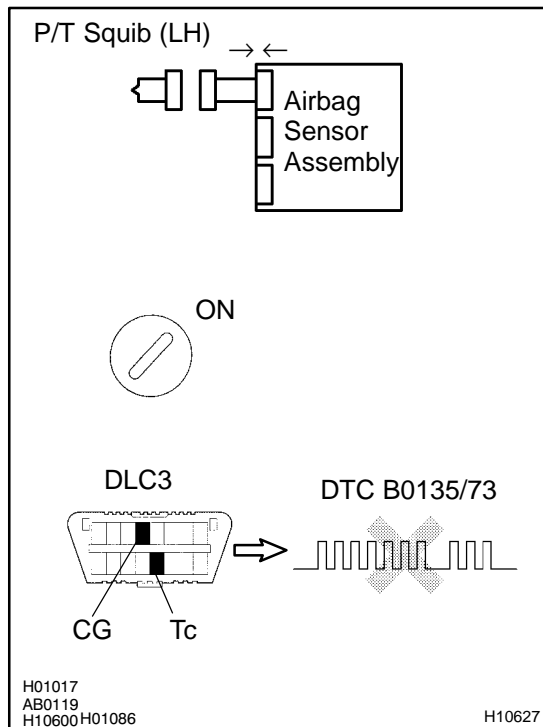
3 Check airbag sensor assembly.

- Connect the connector to the airbag sensor assembly.
- Connect negative (–) terminal cable to the battery, and wait at least for 2 seconds.

- Turn the ignition switch to ON and wait at least for 20 seconds.
- Clear the DTC stored in memory (See page [DI-650](#)).
- Turn the ignition switch to LOCK, and wait at least for 20 seconds.
- Turn the ignition switch to ON, and wait at least for 20 seconds.
- Check the DTC (See page [DI-650](#)).

DTC B0135/73 is not output.

Replace airbag sensor assembly.

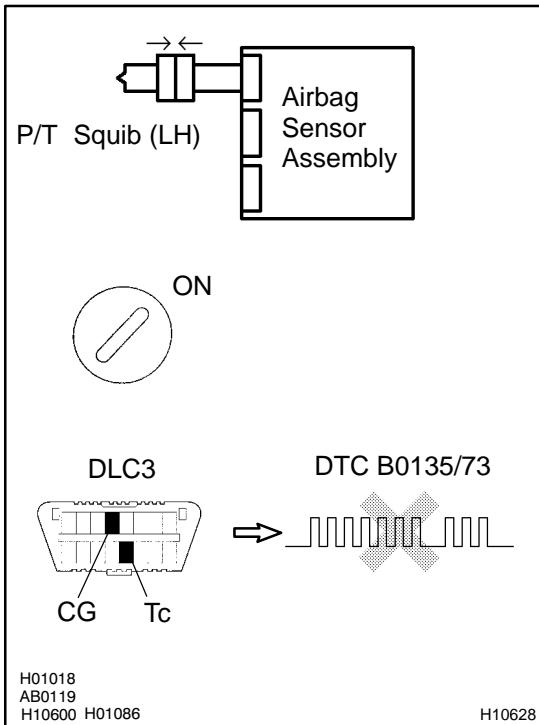
4 Check P/T squib (LH).

- Turn the ignition switch to LOCK.
- Disconnect negative (–) terminal cable from the battery, and wait at least for 90 seconds.
- Connect the seat belt pretensioner (LH) connector.
- Connect negative (–) terminal cable to the battery, and wait at least for 2 seconds.

- Turn the ignition switch to LOCK, and wait at least for 20 seconds.
- Turn the ignition switch to ON, and wait at least for 20 seconds.
- Clear the DTC stored in memory (See page [DI-650](#)).
- Turn the ignition switch to LOCK, and wait at least for 20 seconds.
- Turn the ignition switch to ON, and wait at least for 20 seconds.
- Check the DTC (See page [DI-650](#)).

DTC B0135/73 is not output.

Replace seat belt pretensioner (LH).
