DTC	B0137/71	Short in P/T Squib (LH) Circuit (to Ground)
------------	-----------------	----------------------------------------------------

CIRCUIT DESCRIPTION

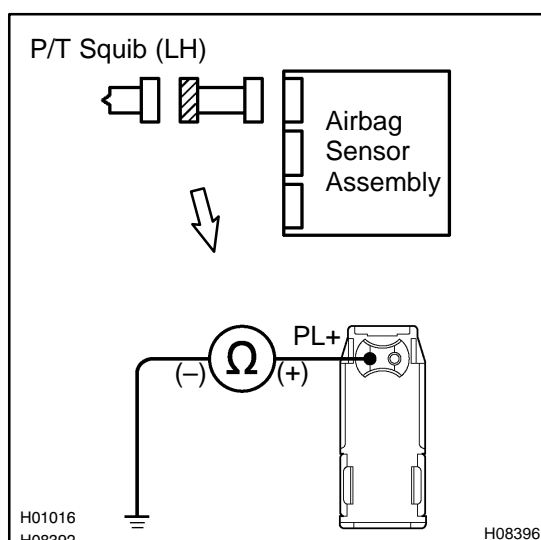
2	Check P/T squib (LH) circuit.
----------	--------------------------------------

CHECK:

For the connector (on the seat belt pretensioner side) between the seat belt pretensioner (LH) and the airbag sensor assembly, measure the resistance between PL+ and body ground.

OK:

Resistance: 1 MΩ or Higher

NG

Repair or replace harness or connector between seat belt pretensioner (LH) and airbag sensor assembly.

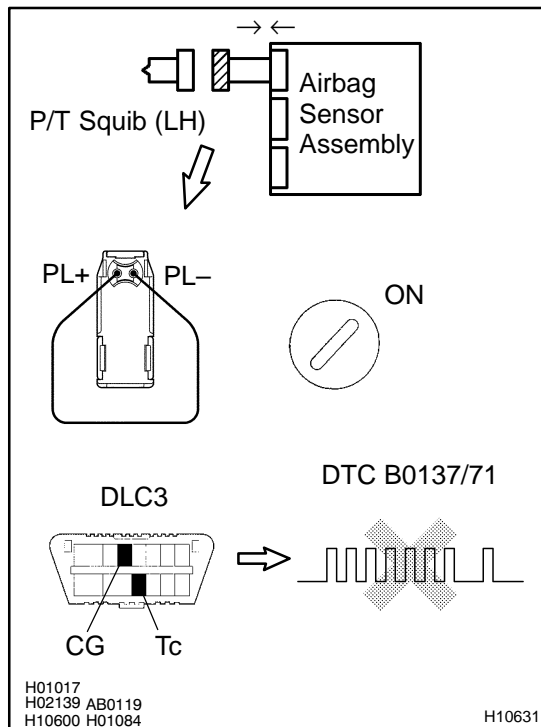
3 Check airbag sensor assembly.

OK:

DTC B0137/71 is not output.

HINT:

Codes other than code B0137/71 may be output at this time, but they are not relevant to this check.

NG

Replace airbag sensor assembly.

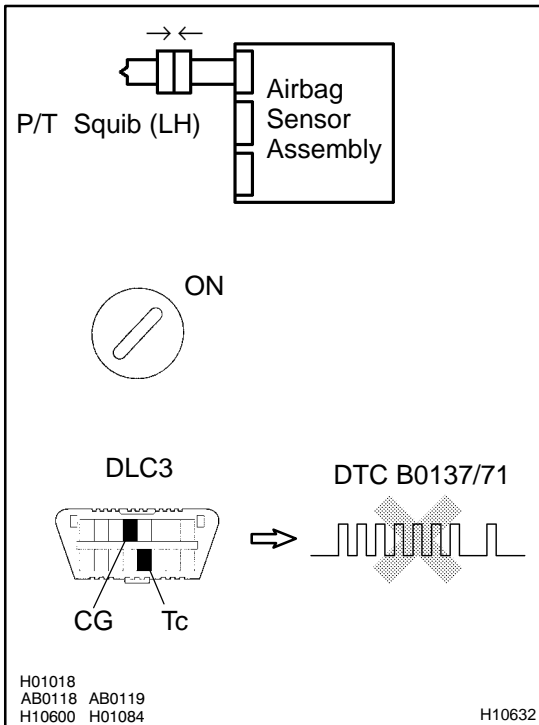
4 Check P/T squib (LH).

**PREPARATION:**

- Turn the ignition switch to LOCK.
- Disconnect negative (–) terminal cable from the battery, and wait at least for 90 seconds.
- Connect the seat belt pretensioner (LH) connector.
- Connect negative (–) terminal cable to the battery, and wait at least for 2 seconds.

CHECK:

- Turn the ignition switch to ON, and wait at least for 20 seconds.
- Clear the DTC stored in memory (See step 5 on page [DI-650](#)).
- Turn the ignition switch to LOCK, and wait at least for 20 seconds.
- Turn the ignition switch to ON, and wait at least for 20 seconds.
- Check the DTC (See page [DI-650](#)).

OK:**DTC B0137/71 is not output.****HINT:**

Codes other than code B0137/71 may be output at this time, but they are not relevant to this check.

NG**Replace seat belt pretensioner (LH).****OK**
