<b>DTC</b>	<b>B0138/72</b>	<b>Short in P/T Squib (LH) Circuit (to B+)</b>
------------	-----------------	--

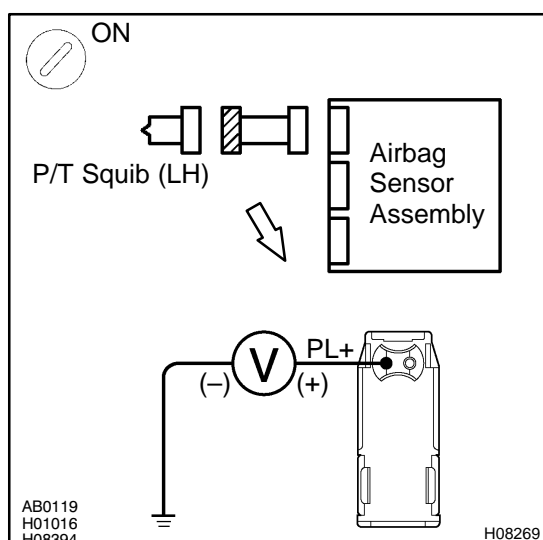
<b>2</b>	<b>Check P/T squib (LH) circuit.</b>
----------	--------------------------------------

- Turn the ignition switch to ON.
- For the connector (on the seat belt pretensioner side) between the seat belt pretensioner (LH) and the airbag sensor assembly, measure the voltage between PL+ and body ground.

**Voltage: 0 V**

**Repair or replace harness or connector between seat belt pretensioner (LH) and airbag sensor assembly.**

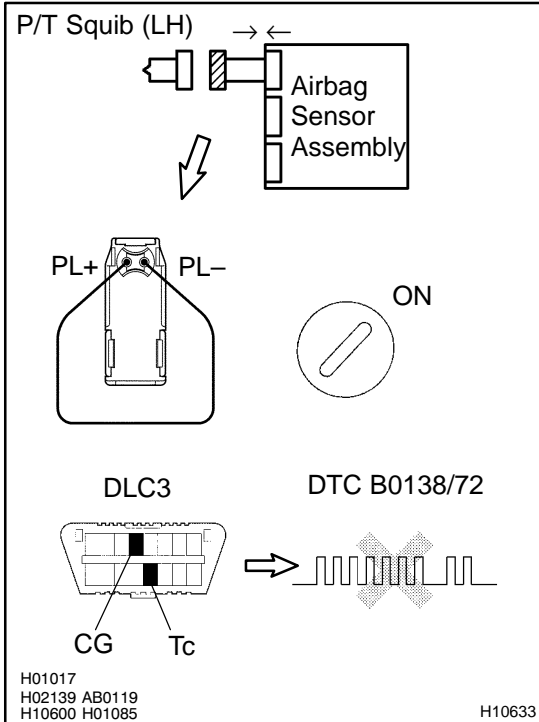
### 3 Check airbag sensor assembly.

- Connect the connector to the airbag sensor assembly.
- Using a service wire, connect PL+ and PL- of the connector (on the seat belt pretensioner side) between the seat belt pretensioner (LH) and the airbag sensor assembly.
- Connect negative (-) terminal cable to the battery, and wait at least for 2 seconds.

- Turn the ignition switch to ON and wait at least for 20 seconds.
- Clear the DTC stored in memory (See step 5 on page [DI-650](#)).
- Turn the ignition switch to LOCK, and wait at least for 20 seconds.
- Turn the ignition switch to ON, and wait at least for 20 seconds.
- Check the DTC (See page [DI-650](#)).

**DTC B0138/72 is not output.**

**Replace airbag sensor assembly.**

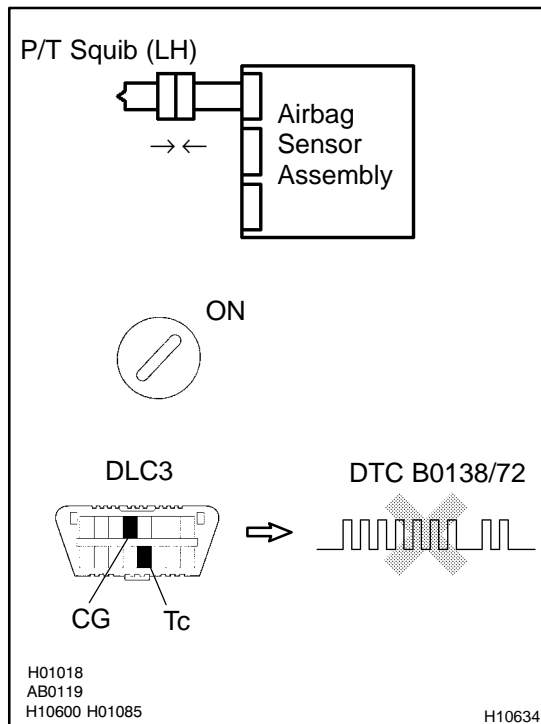
# 4 Check P/T squib (LH).

- Turn the ignition switch to LOCK.
- Disconnect negative (–) terminal cable from the battery, and wait at least for 90 seconds.
- Connect the seat belt pretensioner (LH) connector.
- Connect negative (–) terminal cable to the battery, and wait at least for 2 seconds.

- Turn the ignition switch to ON, and wait at least for 20 seconds.
- Clear the DTC stored in memory (See step 5 on page [DI-650](#)).
- Turn the ignition switch to LOCK, and wait at least for 20 seconds.
- Turn the ignition switch to ON, and wait at least for 20 seconds.
- Check the DTC (See page [DI-650](#)).

**DTC B0138/72 is not output.**

**Replace seat belt pretensioner (LH).**
