ON-VEHICLE INSPECTION

1. INSPECT REFRIGERANT VOLUME

2. INSPECT REFRIGERANT PRESSURE WITH MANIFOLD GAUGE SET

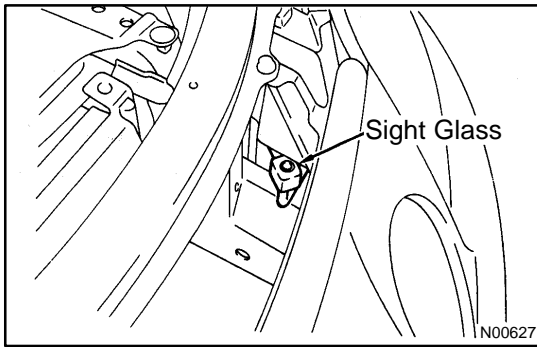
Observe the sight glass on the liquid tube.

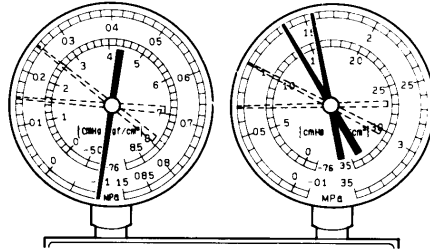
I01387

(2) Moisture present in refrigeration system.

Condition : Periodically cools and then fails to cool

Symptom seen in refrigeration system	Probable cause	Diagnosis	Remedy
During operation, pressure on low pressure side sometimes become a vacuum and sometime normal	Moisture entered in refrigeration system freezes at expansion valve orifice and temporarily stops cycle, but normal state is restored after a time when the ice melts	<ul style="list-style-type: none"> • Drier in oversaturated state • Moisture in refrigeration system freezes at expansion valve orifice and blocks circulation of refrigerant 	(1) Replace receiver (2) Remove moisture in cycle through repeatedly evacuating air (3) Charge proper amount of new refrigerant

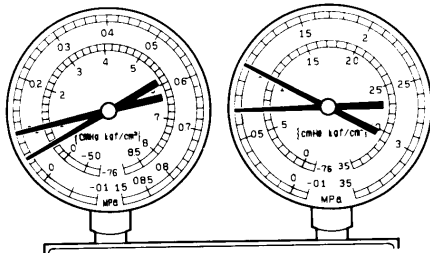
I01388

(3) Insufficient cooling

Condition: Insufficient cooling

Symptom seen in refrigeration system	Probable cause	Diagnosis	Remedy
<ul style="list-style-type: none"> • Pressure low on both low and high pressure sides • Bubbles seen in sight glass continuously • Insufficient cooling performance 	Gas leakage at some place in refrigeration system	<ul style="list-style-type: none"> • Insufficient refrigerant in system • Refrigerant leaking 	(1) Check for gas leakage with gas leak detector and repair if necessary (2) Charge Proper amount of refrigerant (3) If indicated pressure value is near 0 when connected to gauge, create the vacuum after inspecting and repairing the location of the leak

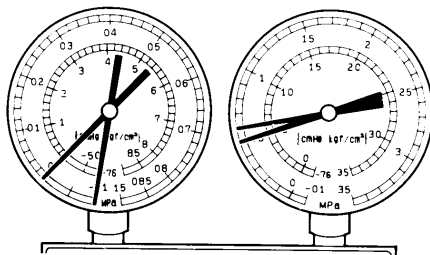
I01389

(4) Poor circulation of refrigerant

Condition: Insufficient cooling

Symptom seen in refrigeration system	Probable cause	Diagnosis	Remedy
<ul style="list-style-type: none"> Pressure low in both low and high pressure sides Frost on tube from receiver to unit 	Refrigerant flow obstructed by dirt in receiver	Receiver clogged	Replace receiver

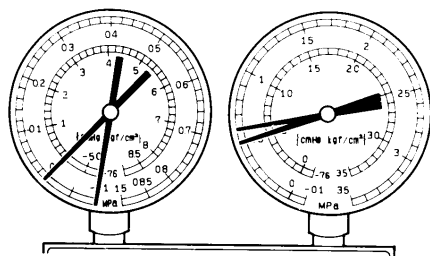
I01449

(5) Refrigerant does not circulate

Condition: Does not cool (Cools from time to time in some cases)

Symptom seen in refrigeration system	Probable cause	Diagnosis	Remedy
<ul style="list-style-type: none"> Vacuum indicated on low pressure side, very low pressure indicated on high pressure side Frost or dew seen on piping before and after receiver/ drier or expansion valve 	<ul style="list-style-type: none"> Refrigerant flow obstructed by moisture or dirt in refrigeration system Refrigerant flow obstructed by gas leakage from expansion valve heat sensing tube 	Refrigerant does not circulate	(1) Check expansion tube, expansion valve and EPR (2) Clean out dirt in expansion valve by blowing with air If not able to remove dirt, replace expansion valve (3) Replace receiver (4) Evacuate air and charge new refrigerant to proper amount (5) For gas leakage from expansion valve, replace expansion valve

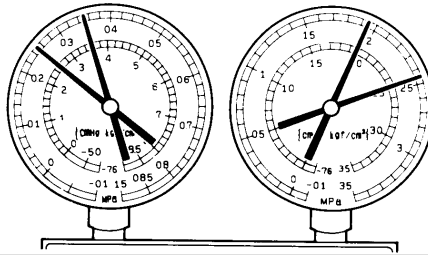
I01390

(6) Refrigerant overcharged or insufficient cooling of condenser

Condition: Insufficient cooling

Symptom seen in refrigeration system	Probable cause	Diagnosis	Remedy
<ul style="list-style-type: none"> Pressure too high on both low and high pressure sides No air bubbles seen through the sight glass even when the engine rpm is lowered 	<ul style="list-style-type: none"> Unable to develop sufficient performance due to excessive refrigerant in system Insufficient cooling of condenser 	<ul style="list-style-type: none"> Excessive refrigerant in cycle → refrigerant overcharged Condenser cooling → condenser fins clogged or condenser fan faulty. 	<ol style="list-style-type: none"> Clean condenser Check condenser fan motor operation If (1) and (2) are in normal state, check amount of refrigerant. Charge proper amount of refrigerant.

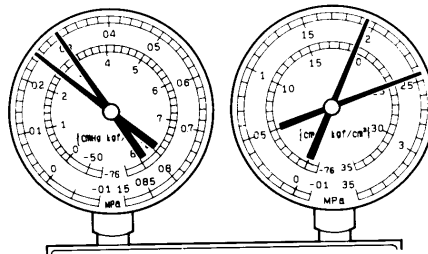
I01392

(7) Air present in refrigeration system

Condition: Insufficient cooling

NOTE : These gauge indications are shown when the refrigeration system has been opened and the refrigerant charged without vacuum purging.

Symptom seen in refrigeration system	Probable cause	Diagnosis	Remedy
<ul style="list-style-type: none"> Pressure too high on both low and high pressure sides The low pressure piping hot to the touch Bubbles seen in sight glass 	Air entered in refrigeration system	<ul style="list-style-type: none"> Air present in refrigeration system Insufficient vacuum purging 	<ol style="list-style-type: none"> Check compressor oil to see if it is dirty or insufficient Evacuate air and charge new refrigerant

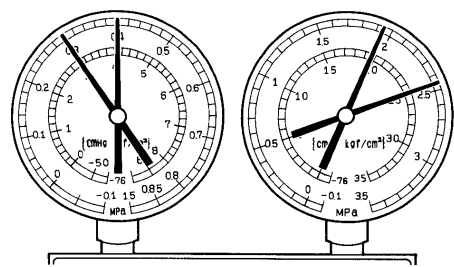
I16787

(8) Expansion valve improperly mounted/heat sensing tube defective (opens too wide)

Condition: Insufficient cooling

Symptom seen in refrigeration system	Probable cause	Diagnosis	Remedy
<ul style="list-style-type: none">• Pressure too high on both low and high pressure sides• Frost or large amount of dew on piping on low pressure side	Trouble in expansion valve or heat sensing tube not installed correctly	<ul style="list-style-type: none">• Excessive refrigerant in low pressure piping• Expansion valve opened too wide	<p>(1) Check heat sensing tube installed condition</p> <p>(2) If (1) is normal, check expansion valve</p> <p>Replace if defective</p>

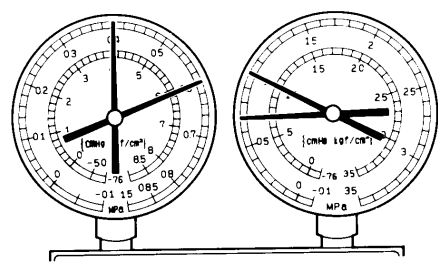
I01393

(9) Defective compression compressor

Condition : Does not cool

Symptom seen in refrigeration system	Probable cause	Diagnosis	Remedy
<ul style="list-style-type: none">• Pressure too high on low and high pressure sides• Pressure too low on high pressure side	Internal leak in compressor	<ul style="list-style-type: none">• Compression defective• Valve leaking or broken sliding parts	Repair or replace compressor

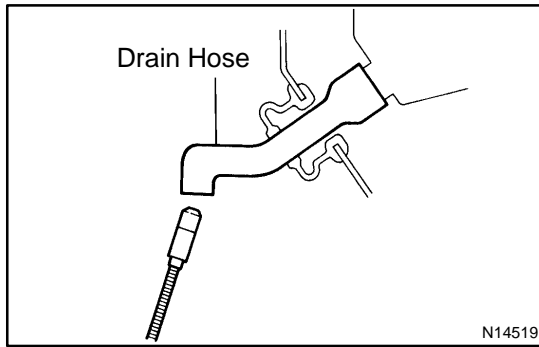
- (b) Bring the gas leak detector close to the drain hose before performing the test.

- After the blower motor is stopped, leave the A/C unit for more than 15 minutes.
- Expose the gas leak detector sensor under the drain hose.
- When bring the gas leak detector close to the drain hose, make sure that the gas leak detector does not react to the volatile gases.

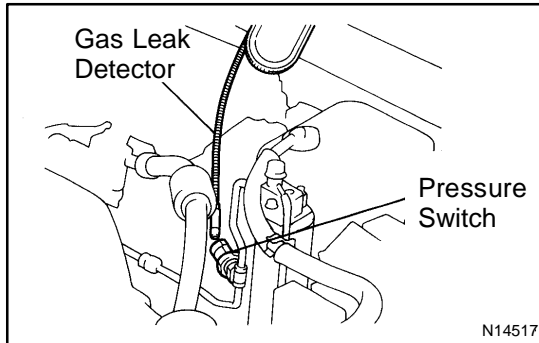
If such reaction is unavoidable, the vehicle must be lifted up.

- (c) If gas leak is not detected on the drain hose, remove the evaporator cover from the A/C unit. Then insert the gas leak detector sensor into the unit and perform the test.
- (d) Disconnect the connector and leave the pressure switch for approx. 20 minutes. Then bring the gas leak detector close to the pressure switch and perform the test.
- (e) Bring the gas leak detector close to the refrigerant lines and perform the test.
